Physical Habitat Dynamics in Four Side-channel Chutes, Lower Missouri River

By Robert B. Jacobson, Harold E. Johnson, Mark S. Lastrup, Gary J. D'Urso, and Joanna M. Reuter

Open-File Report 2004-1071

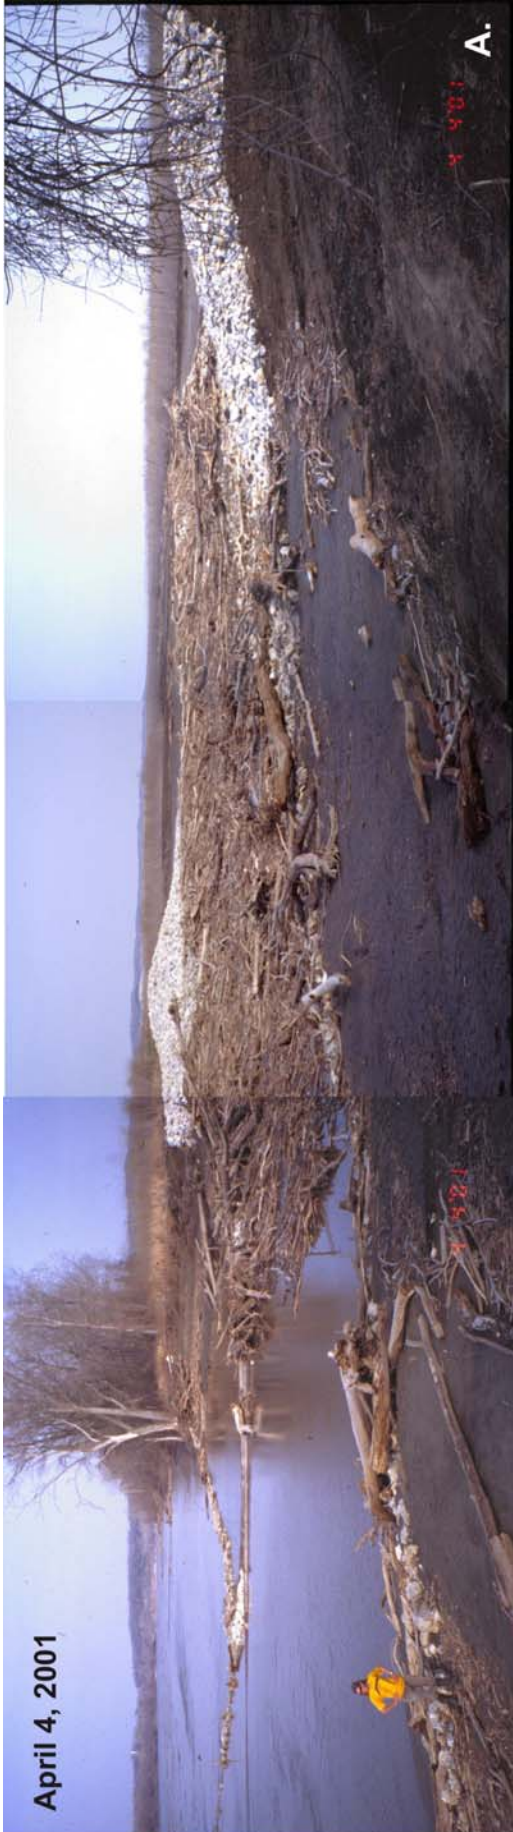
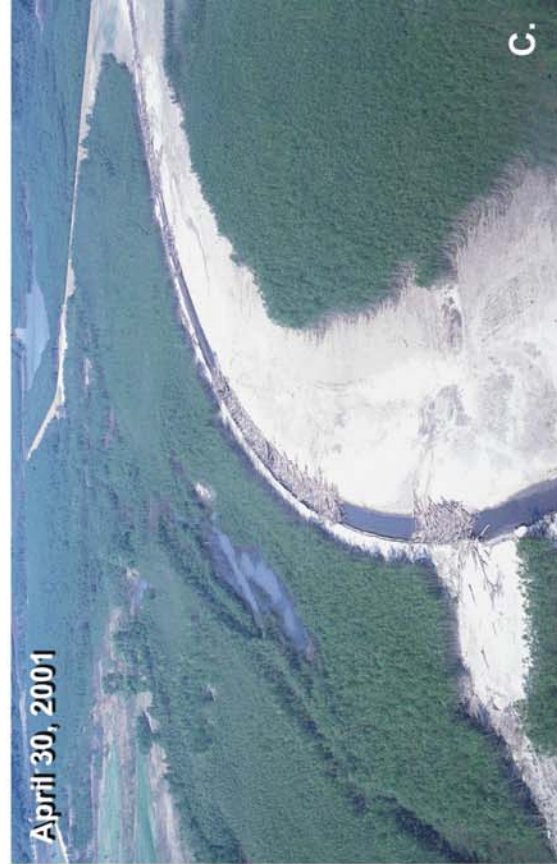
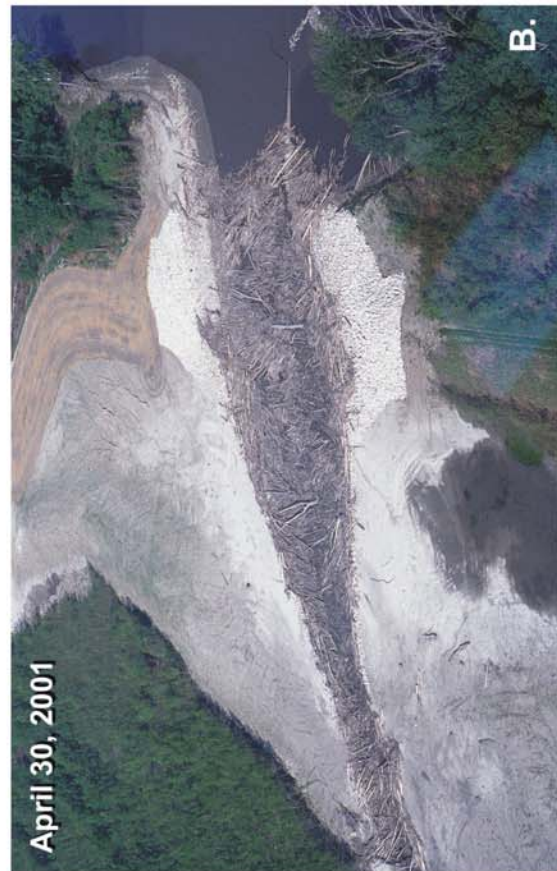
Figure 34. Photographs of large woody debris jam in North Overton Bottoms side-channel chute. A. Inlet, looking downstream; navigation channel to left. Photo courtesy of Missouri Department of Conservation. B. Inlet from oblique aerial photograph. Photo courtesy of Missouri Department of Conservation. C. Upstream one third of chute. Photo courtesy of Missouri Department of Conservation.

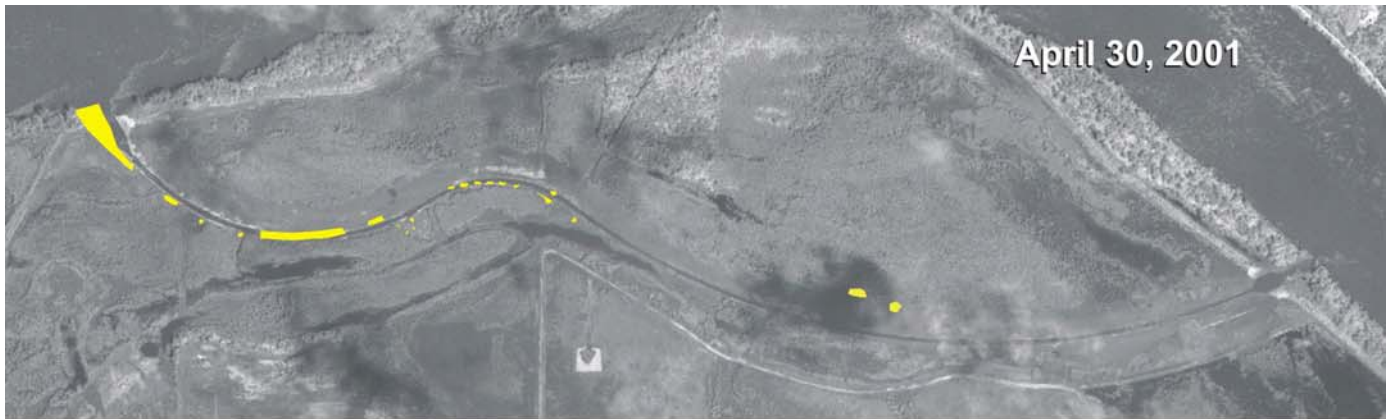
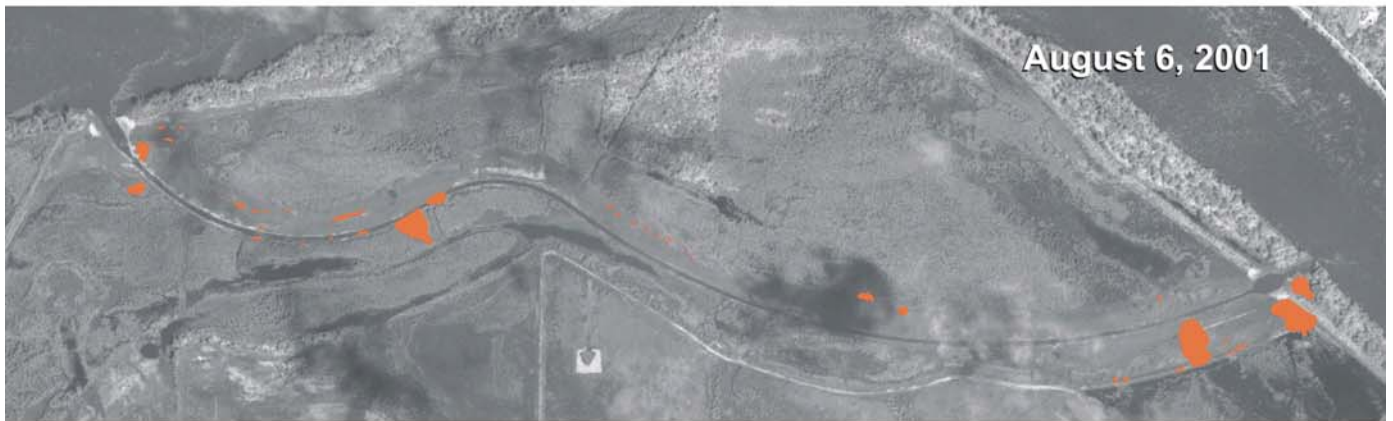
Figure 35. Maps of large woody debris accumulation at North Overton Bottoms side-channel chute, March 2001 to September 2002. Hydrologic record and map dates are shown in figure 33.

LWD also was evaluated using oblique aerial photography and videography collected by the Missouri Department of Conservation in waterfowl studies (Dale Humburg, Missouri Department of Conservation, personal communication, 2003). Accumulation of LWD was clearly the most dramatic geomorphic response of the Overton side-channel chute (figs. 34). LWD accumulation over time was evaluated using oblique aerial imagery. This method provides semi-quantitative assessment of how much, when, and where LWD accumulated in the chute. Aerial photography dates are shown in figure 33 and maps of LWD are shown in figure 35. Little LWD accumulated in the chute during the winter 2000-2001. In February and March, 2001, three floods overflowed the inlet, each successively larger in discharge. Photographs taken on March 3 between the second and third flood indicated initial accumulation of LWD in a jam on the second bend near station 1100 m. The third flood on March 18, 2001 was about 200,000 cfs. Photographs taken March 19 showed that the inlet was packed with LWD, the LWD on the second bend was breached, and an LWD jam had expanded on the second bend. Water continued flowing through the inlet until mid July 2001. On March 26, more LWD was apparent and the LWD distribution was little changed on April 30.

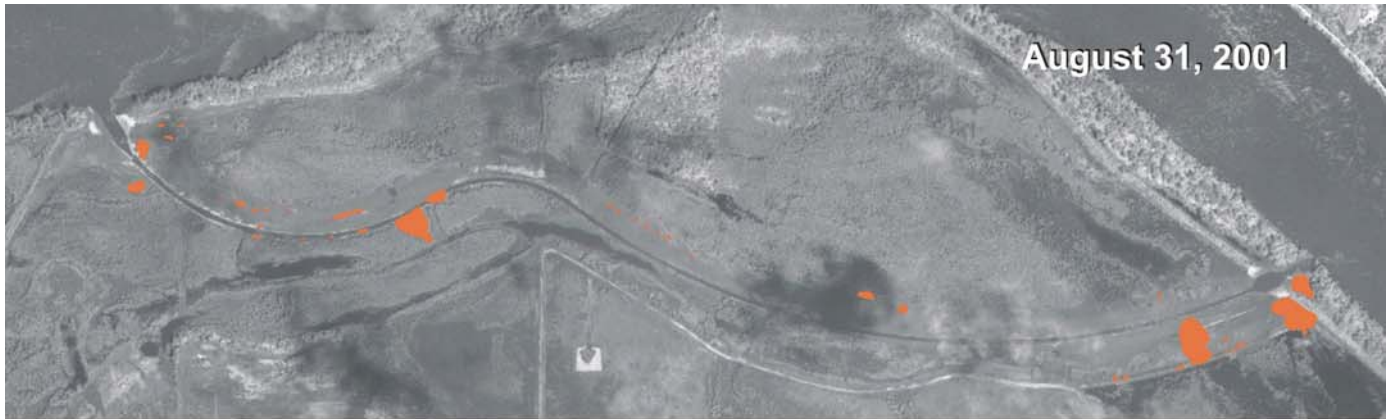
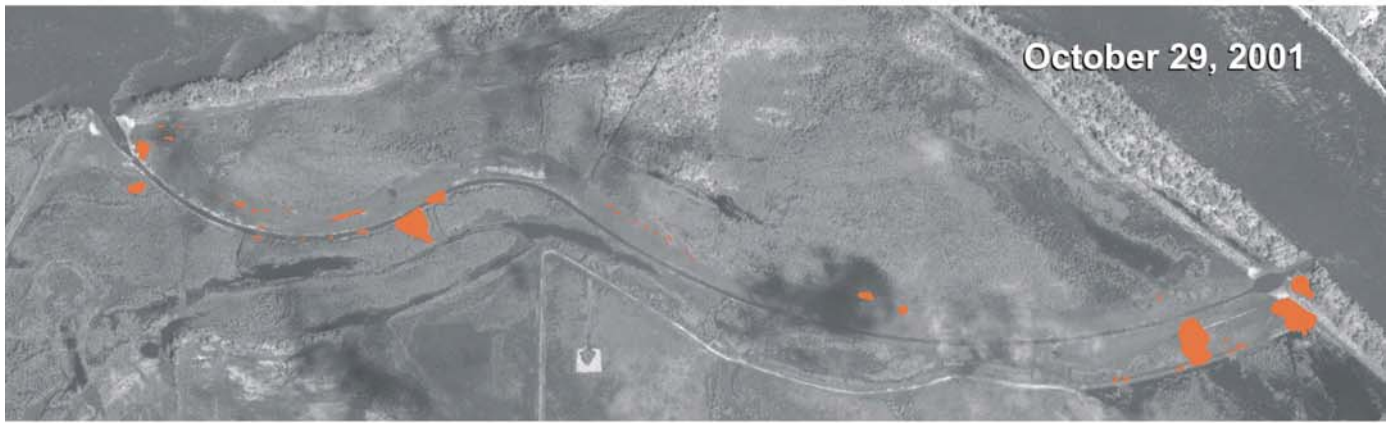
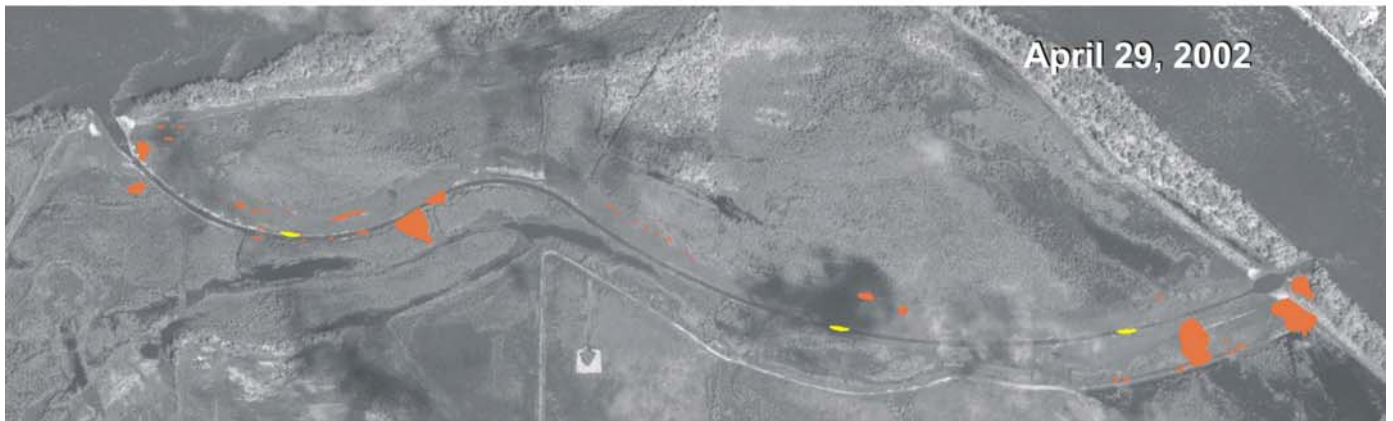
Figure 35 (cont.). Maps of large woody debris accumulation at North Overton Bottoms side-channel chute, March 2001 to September 2002. Hydrologic record and map dates are shown in figure 33.

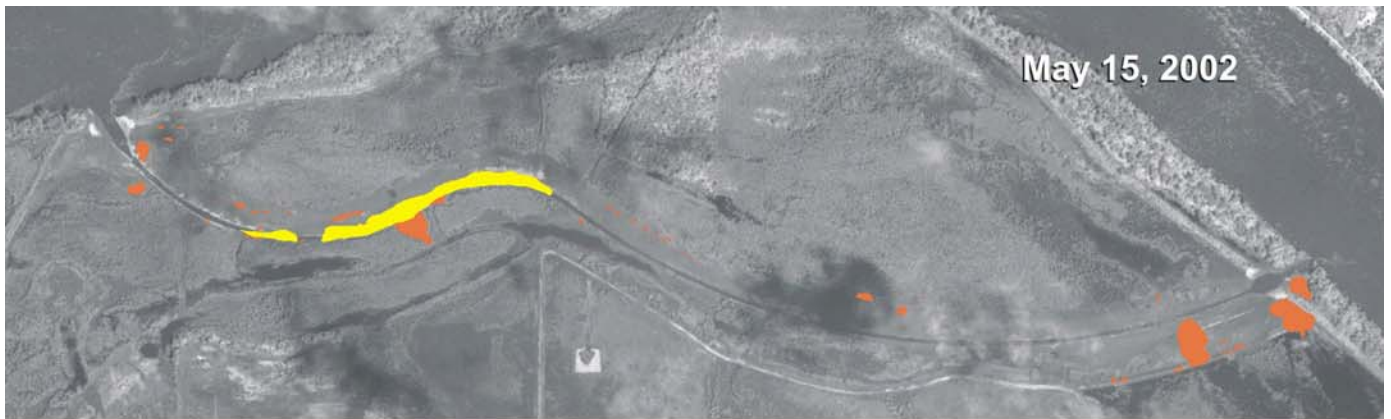
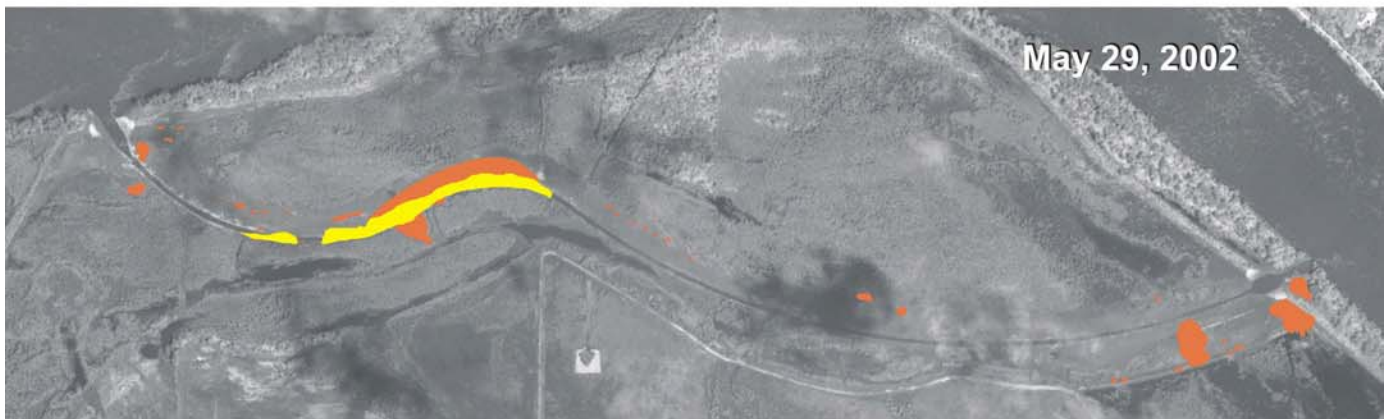
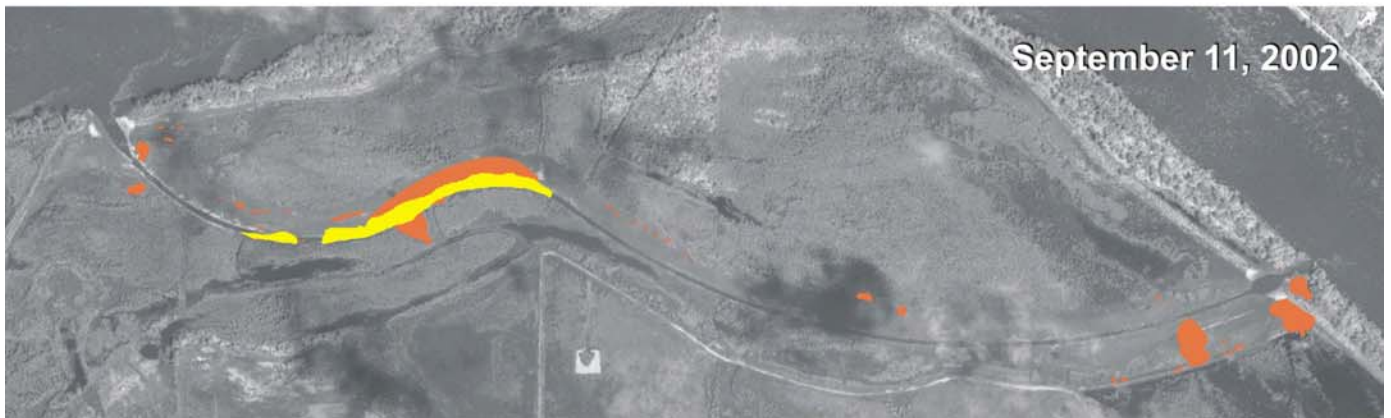
Figure 35 (cont.). Maps of large woody debris accumulation at North Overton Bottoms side-channel chute, March 2001 to September 2002. Hydrologic record and map dates are shown in figure 33.
